Coyote Point Promenade Western Shoreline: Final Programmatic Report (AMENDED)

Recipient Organization/Agency: San Mateo County Department of Parks

Date Submitted: October 08 2014

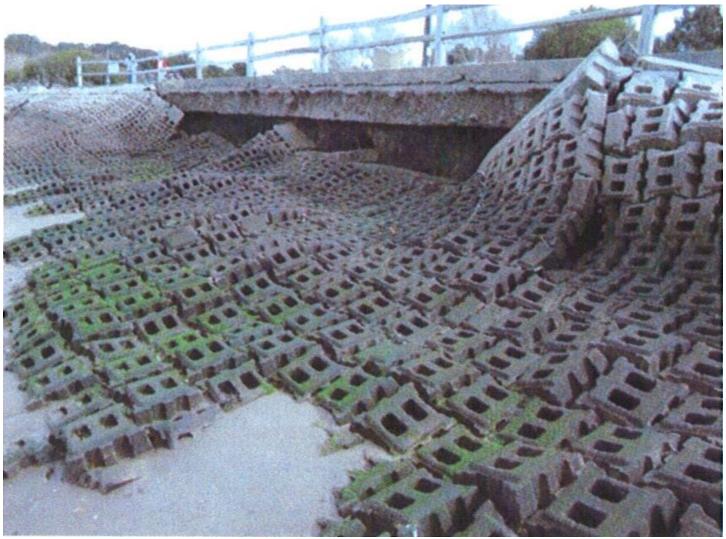
Image 1: Photo shows failed shoreline armoring prior to the project. Concrete blocks have separated from the Promenade pathway. Public access ramps for watersports are neither safe nor easy to use.

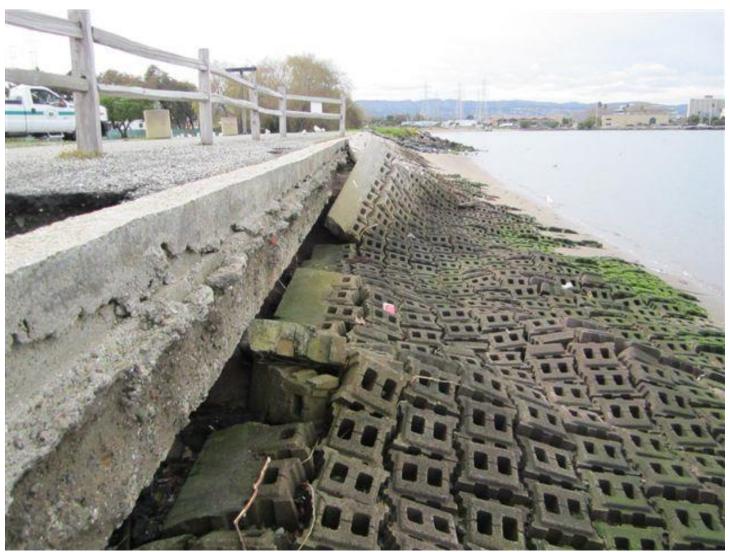
Image 2: Photo shows buckling of public access ramps and lack of revetment prior to the project.

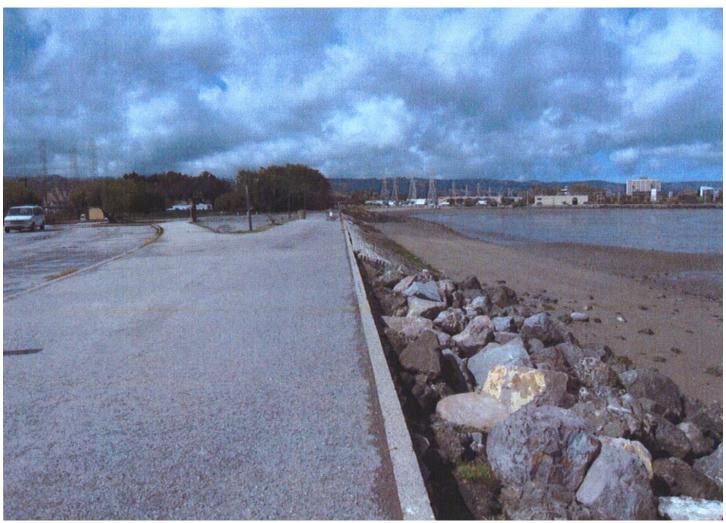
Image 3: Prior to the project, revetment boulders were no longer in effective placement to protect the Promenade. In addition, Promenade trail users had no curb between the trail and revetment.

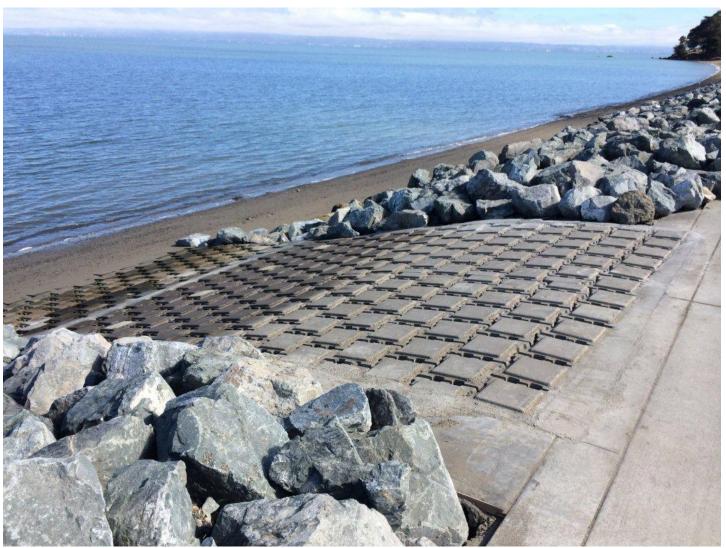
Image 4: Well-engineered access ramp is shown (post-project). The ramp has interlocking blocks, is flush with Promenade trail, is built down to the bay mud, and is well defined amidst the revetment.

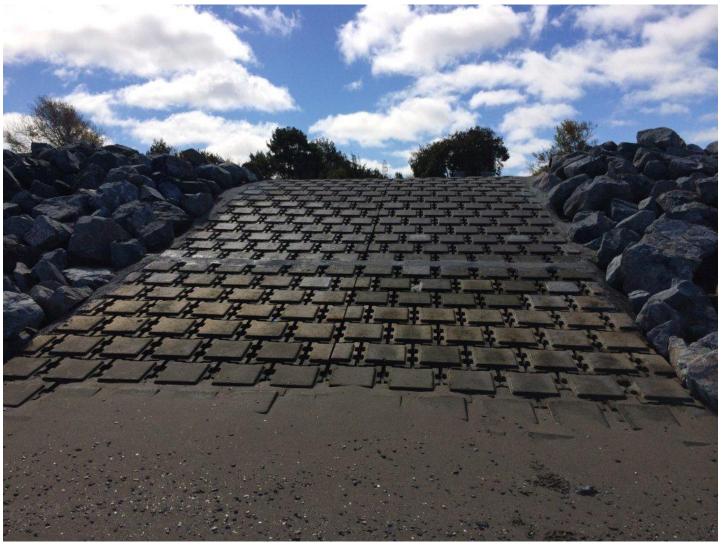
Image 6: View of new access ramp from Bay at low tide (post-project). Shows easy access from the Bay to the Promenade for recreational users who carry boats, boards and sails.

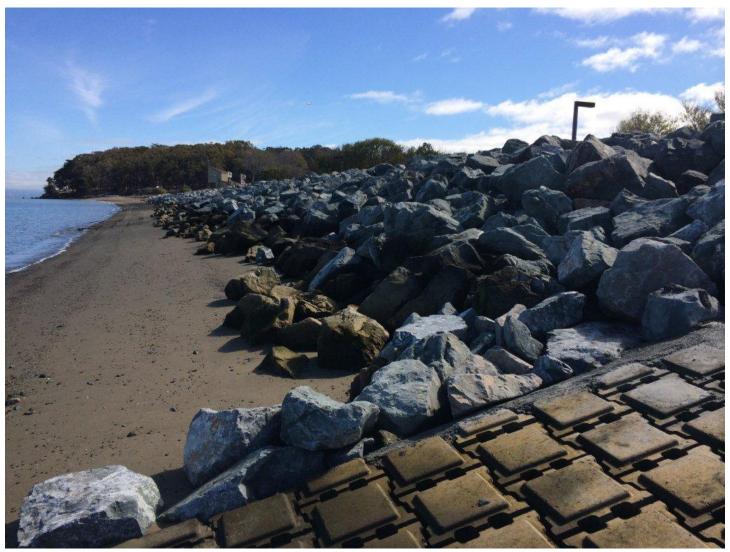
Image 7: View of another new ramp and shoreline revetment built to withstand tides and wind (post-project).

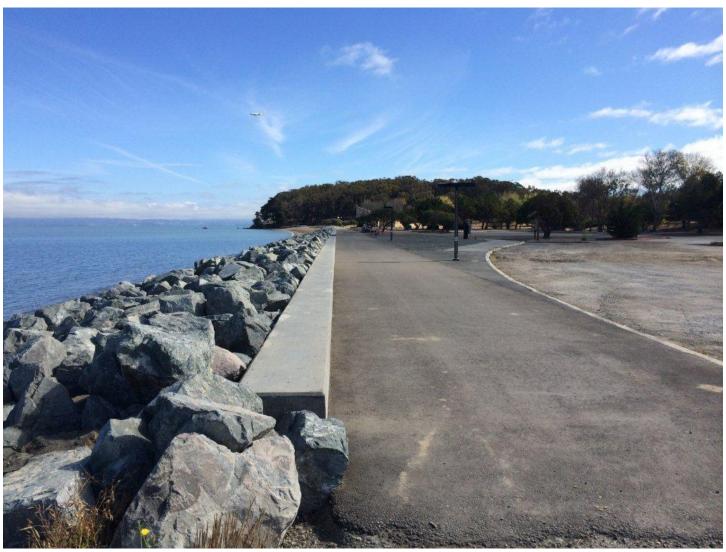
Image 8: View of Promenade showing newly paved trail that links to other park pathways (post project). Photo shows new curb/seating wall and adequate revetment.
